Suydam Dam, NDS ID PA 00085, DER ID 64-169
Delaware River Basin, Lollipop Creek,
Wayne County, Pennsylvania. Phase I
Inspection Report.

SUYDAM DAM
WAYNE COUNTY, PENNSYLVANIA

NDS. I.D. NO. PA 00085
DER I.D. NO. 64-169

PHASE I INSPECTION REPORT
NATIONAL DAM INSPECTION PROGRAM

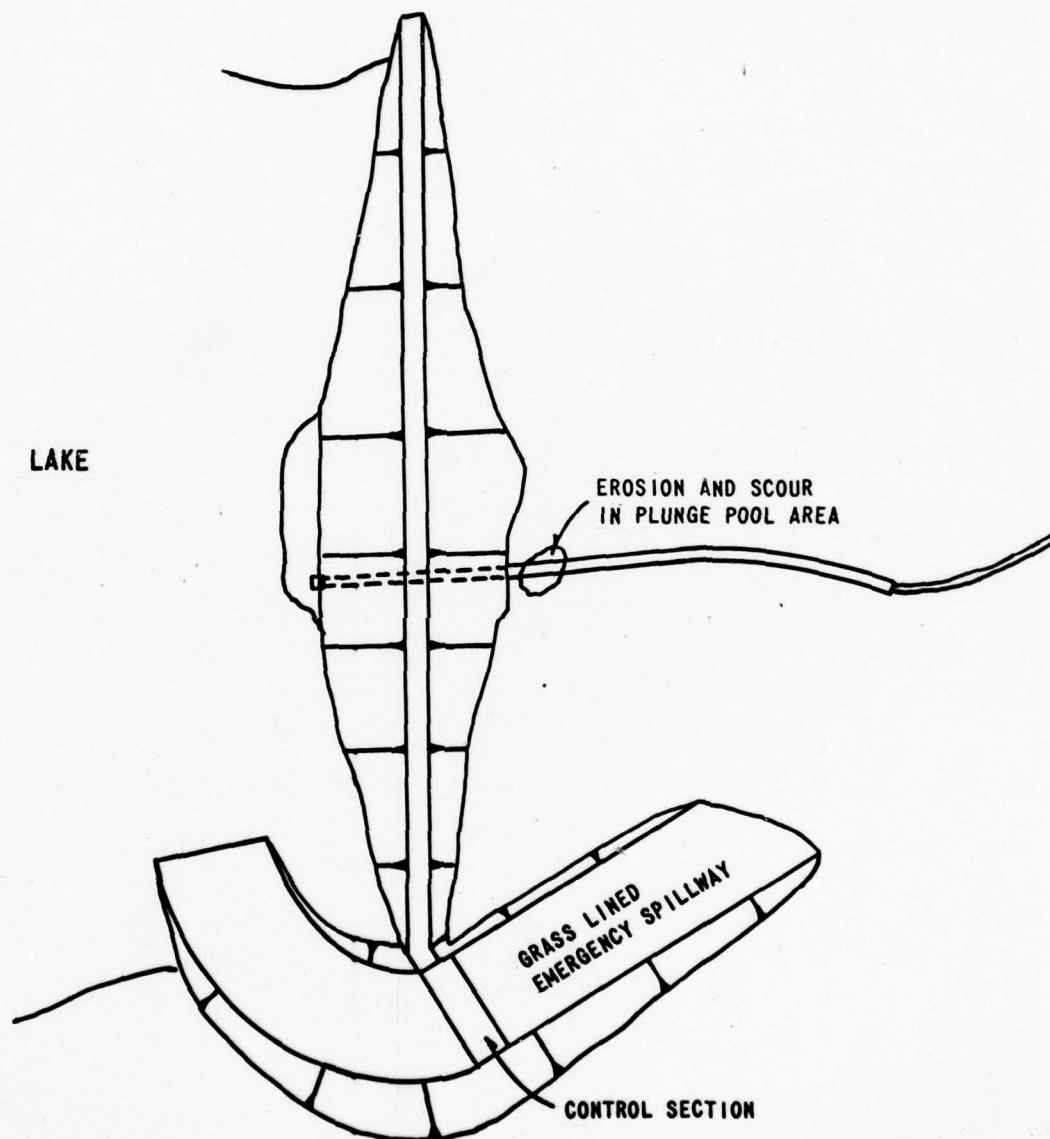
SEEPAGE LOCATION PLAN
SUYDAM DAM

Two - 6 inch CMP were observed on each side of the principal spillway outlet pipe. Both were seeping water at rates of less than 0.01 gpm.

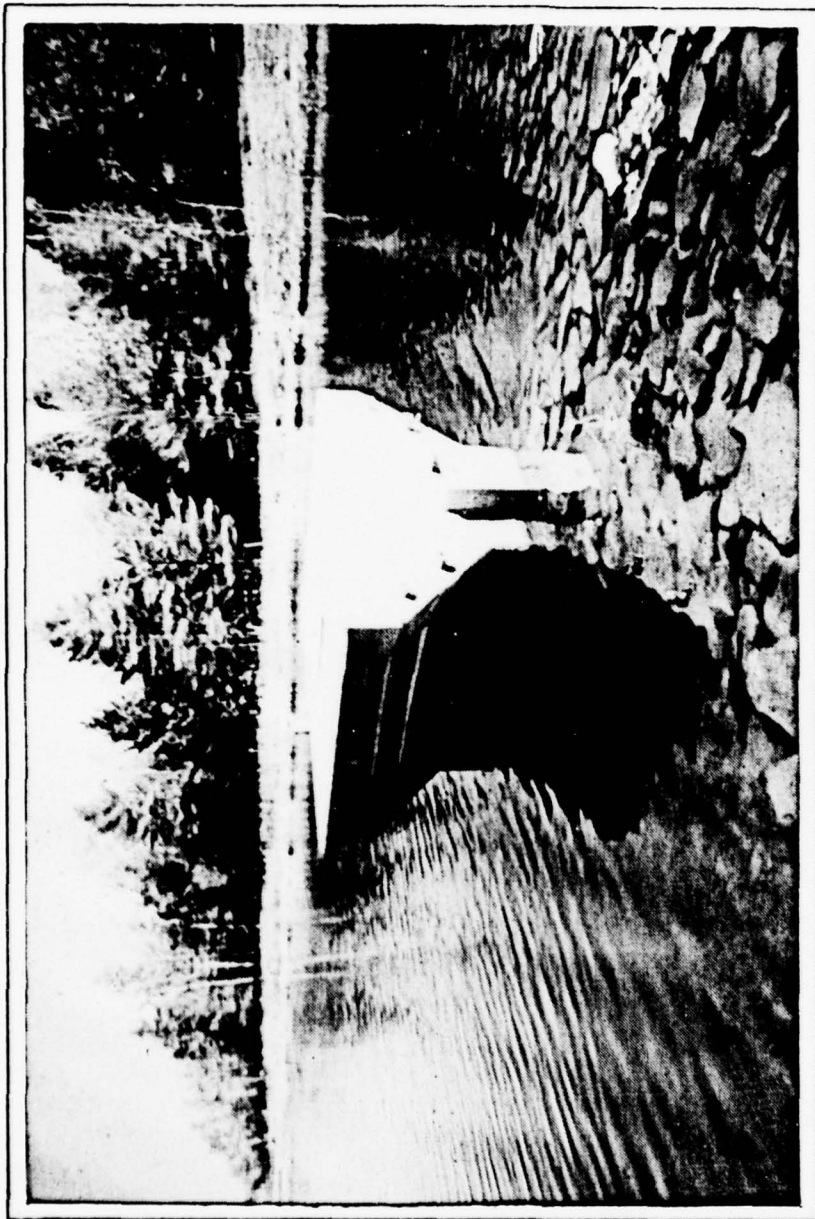
PHOTOGRAPH NO. 1

c. Appurtenant Structures. At the time of the inspection, water was flowing over the principal spillway weir. Portions of the riser visible from the embankment were inspected and observed to be in good condition with no signs of distress, concrete spalling, or other indications of poor construction or movement of the riser. The interior of the intake riser could not be inspected since a key was not available. Similarly, the sluice gate could not be exercised since a key to the lock was not available. However, the valve was cleaned, painted and appeared to be well lubricated.

VIEW OF THE INTAKE RISER, PRINCIPAL
SPILLWAY.

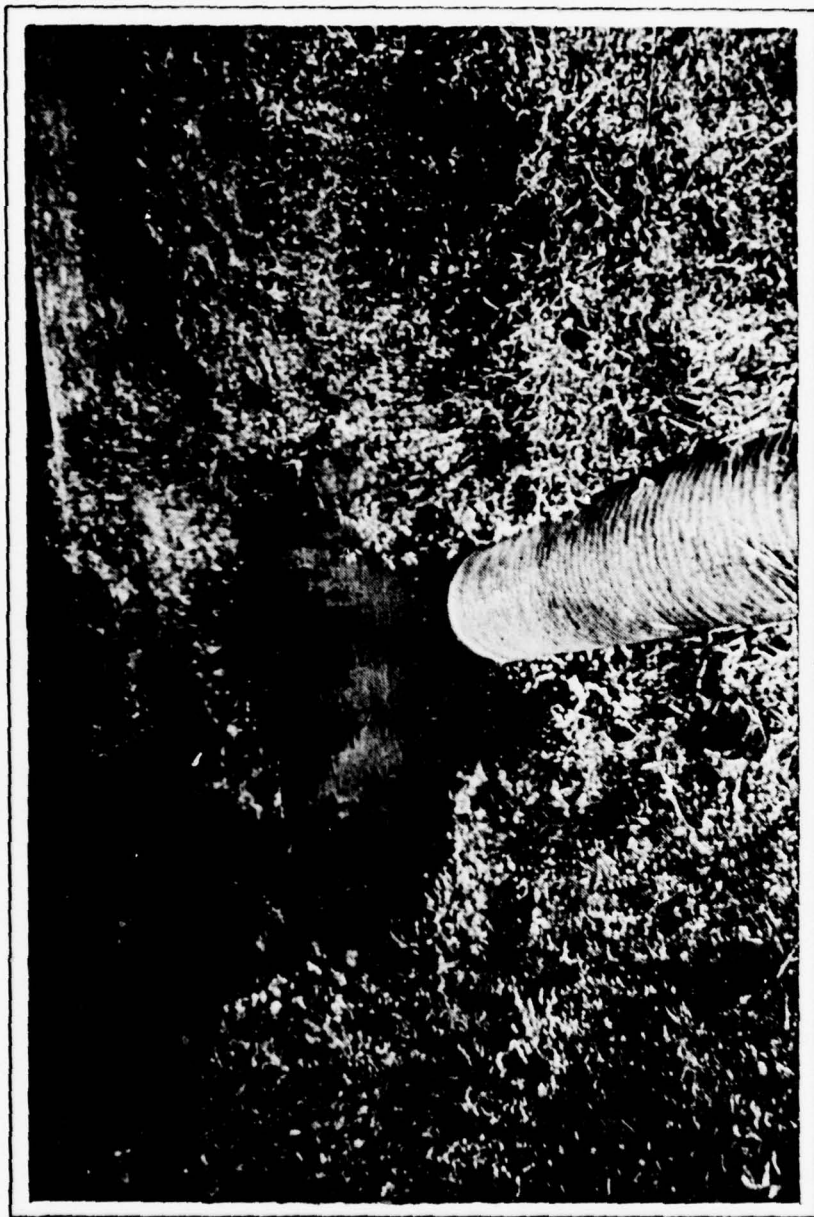
PHOTOGRAPH NO. 2

The length of the discharge pipe could not be inspected primarily because of its size and the fact that water was flowing through the principal spillway pipe. However, the end of the pipe was inspected and observed to be in fairly good condition. The plunge pool at the downstream toe was inspected and observed to be in fair condition. There was some sloughing and erosion of primarily the right slope of the basin, which is continuing to eat away at the right side of the slope. Although this condition of sloughing and erosion of the discharge basin is not considered to be detrimental to the performance of the dam, continued erosion could lead to undermining of the principal spillway bent.

PRINCIPAL SPILLWAY. DISCHARGE PIPE.

1. The plunge pool should be checked after each severe storm for scour and for possible undermining of the spillway bent. Should excessive scour occur, the plunge pool should be rehabilitated.

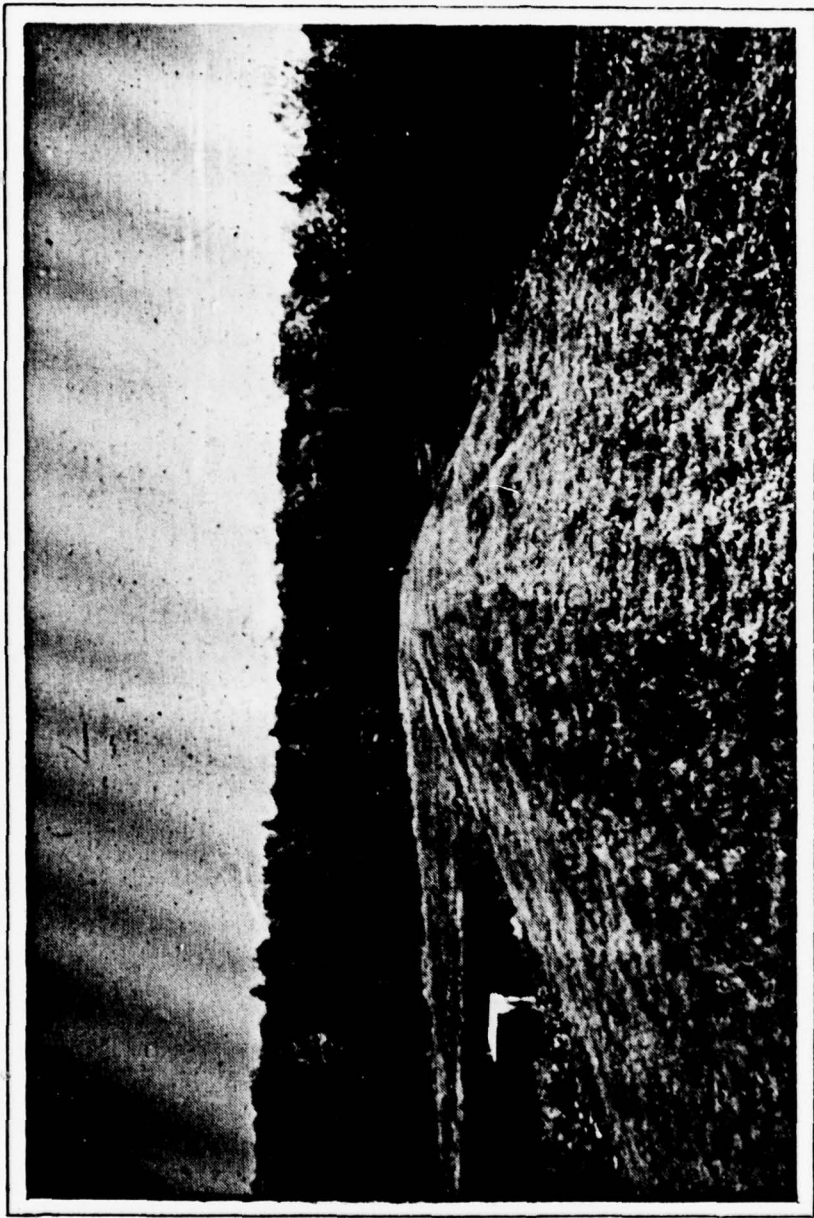
PHOTOGRAPH NO. 3

OVERVIEW OF DAM AND UPSTREAM SLOPE.

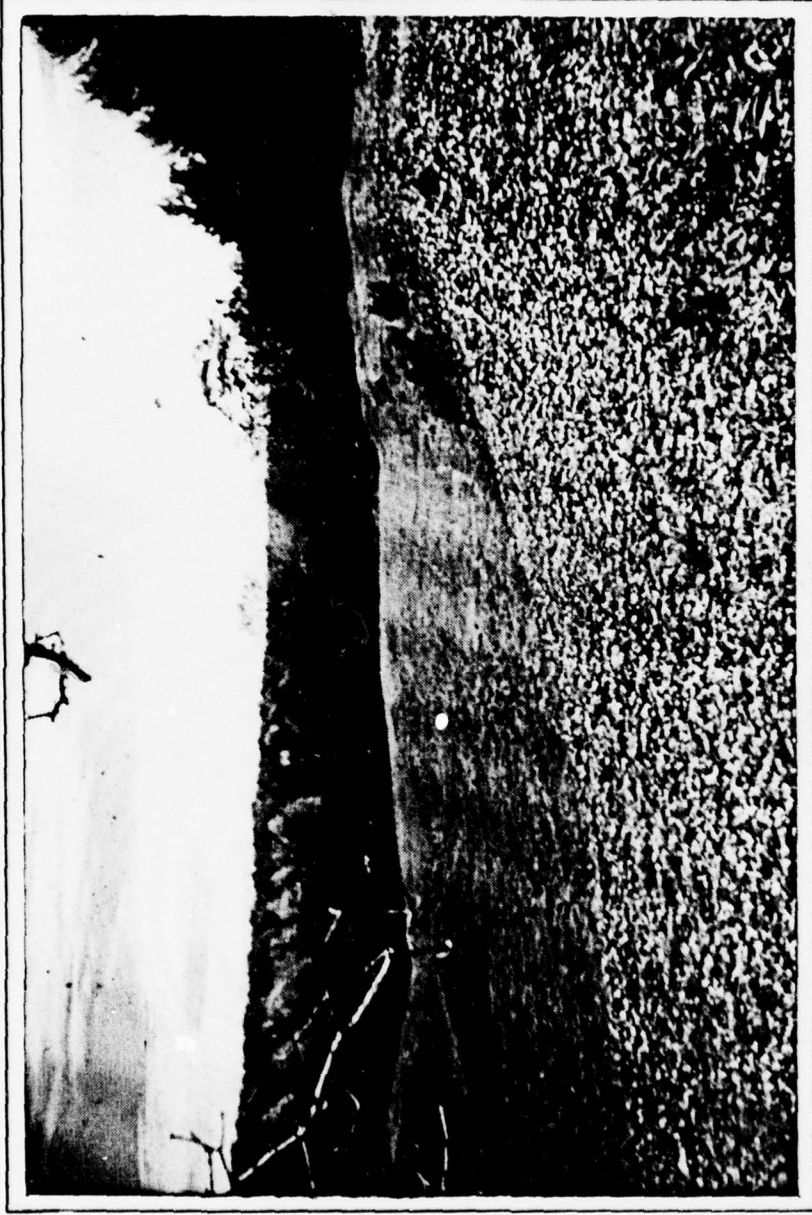
PHOTOGRAPH NO. 5

The emergency spillway is located at the right abutment of the dam and was inspected and observed to be in good condition. Both the channel bottom and the side hill slopes are well vegetated and appear to be well maintained. Both the emergency spillway entrance and exit are also in good condition.

OVERVIEW OF EMERGENCY SPILLWAY.
LOOKING DOWNSTREAM.

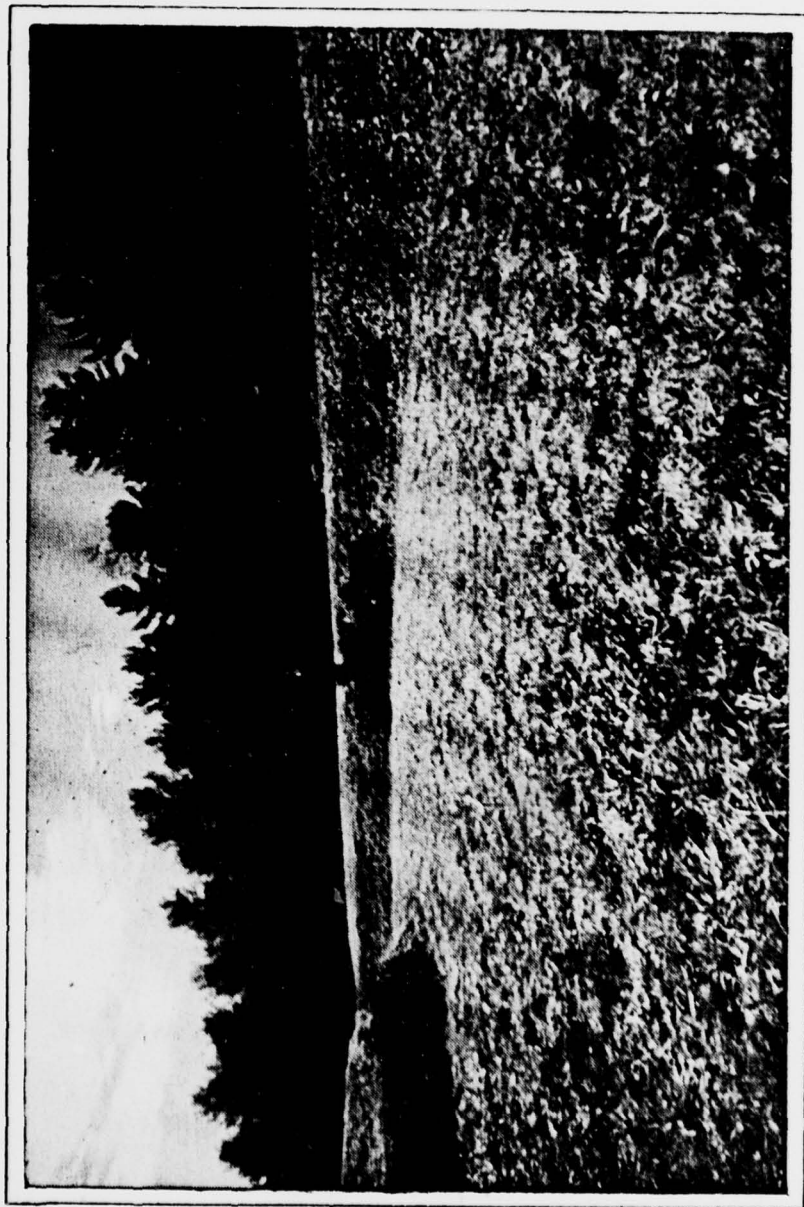
EMERGENCY SPILLWAY LOOKING
DOWNSTREAM.

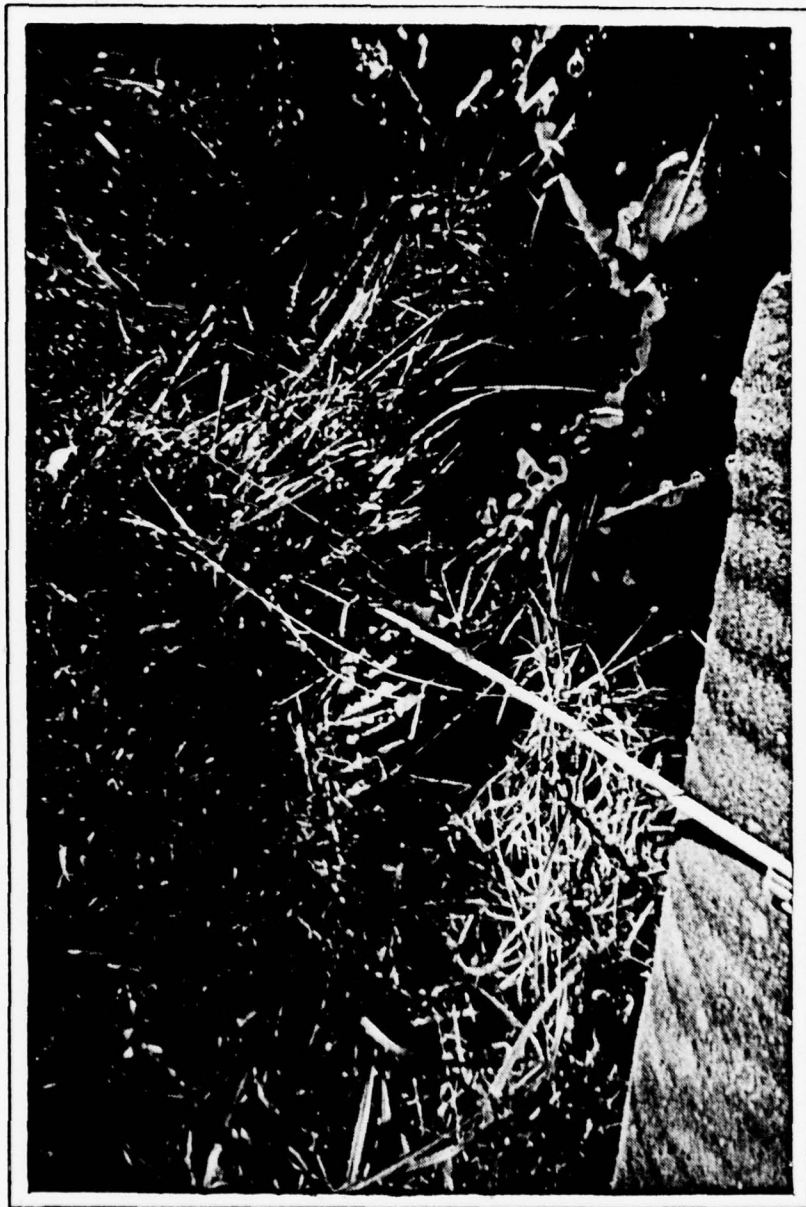
PHOTOGRAPH NO. 7

VIEW OF 6 INCH ID EMBANKMENT
DRAINAGE PIPE LOCATED ON LEFT
SIDE OF PRINCIPAL SPILLWAY
DISCHARGE PIPE.

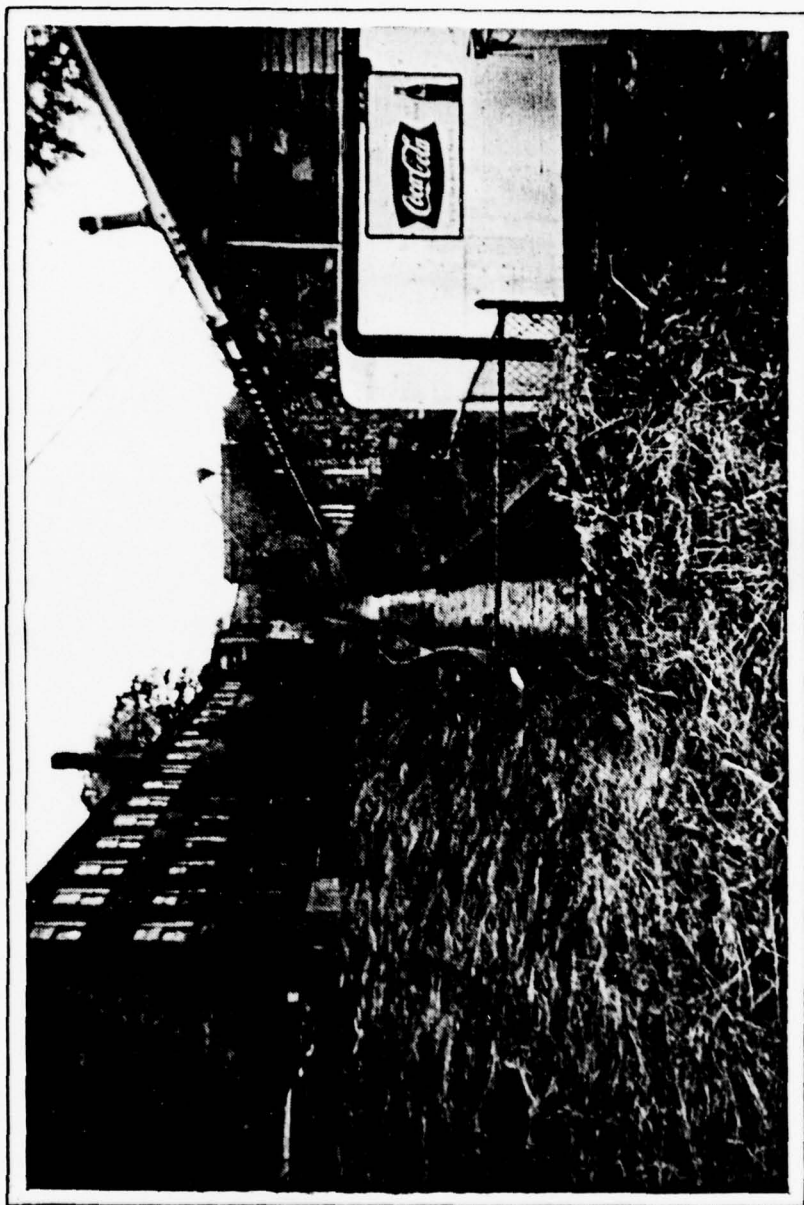
PHOTOGRAPH NO. 12

DISCHARGE CHANNEL THROUGH TOWN.
